Bridger Range Longitude -110.93W Latitude 45.84N

Forecast link: <u>GNFAC Avalanche Forecast for Mon Apr 6, 2020</u> Bridger Range, 2020-04-05

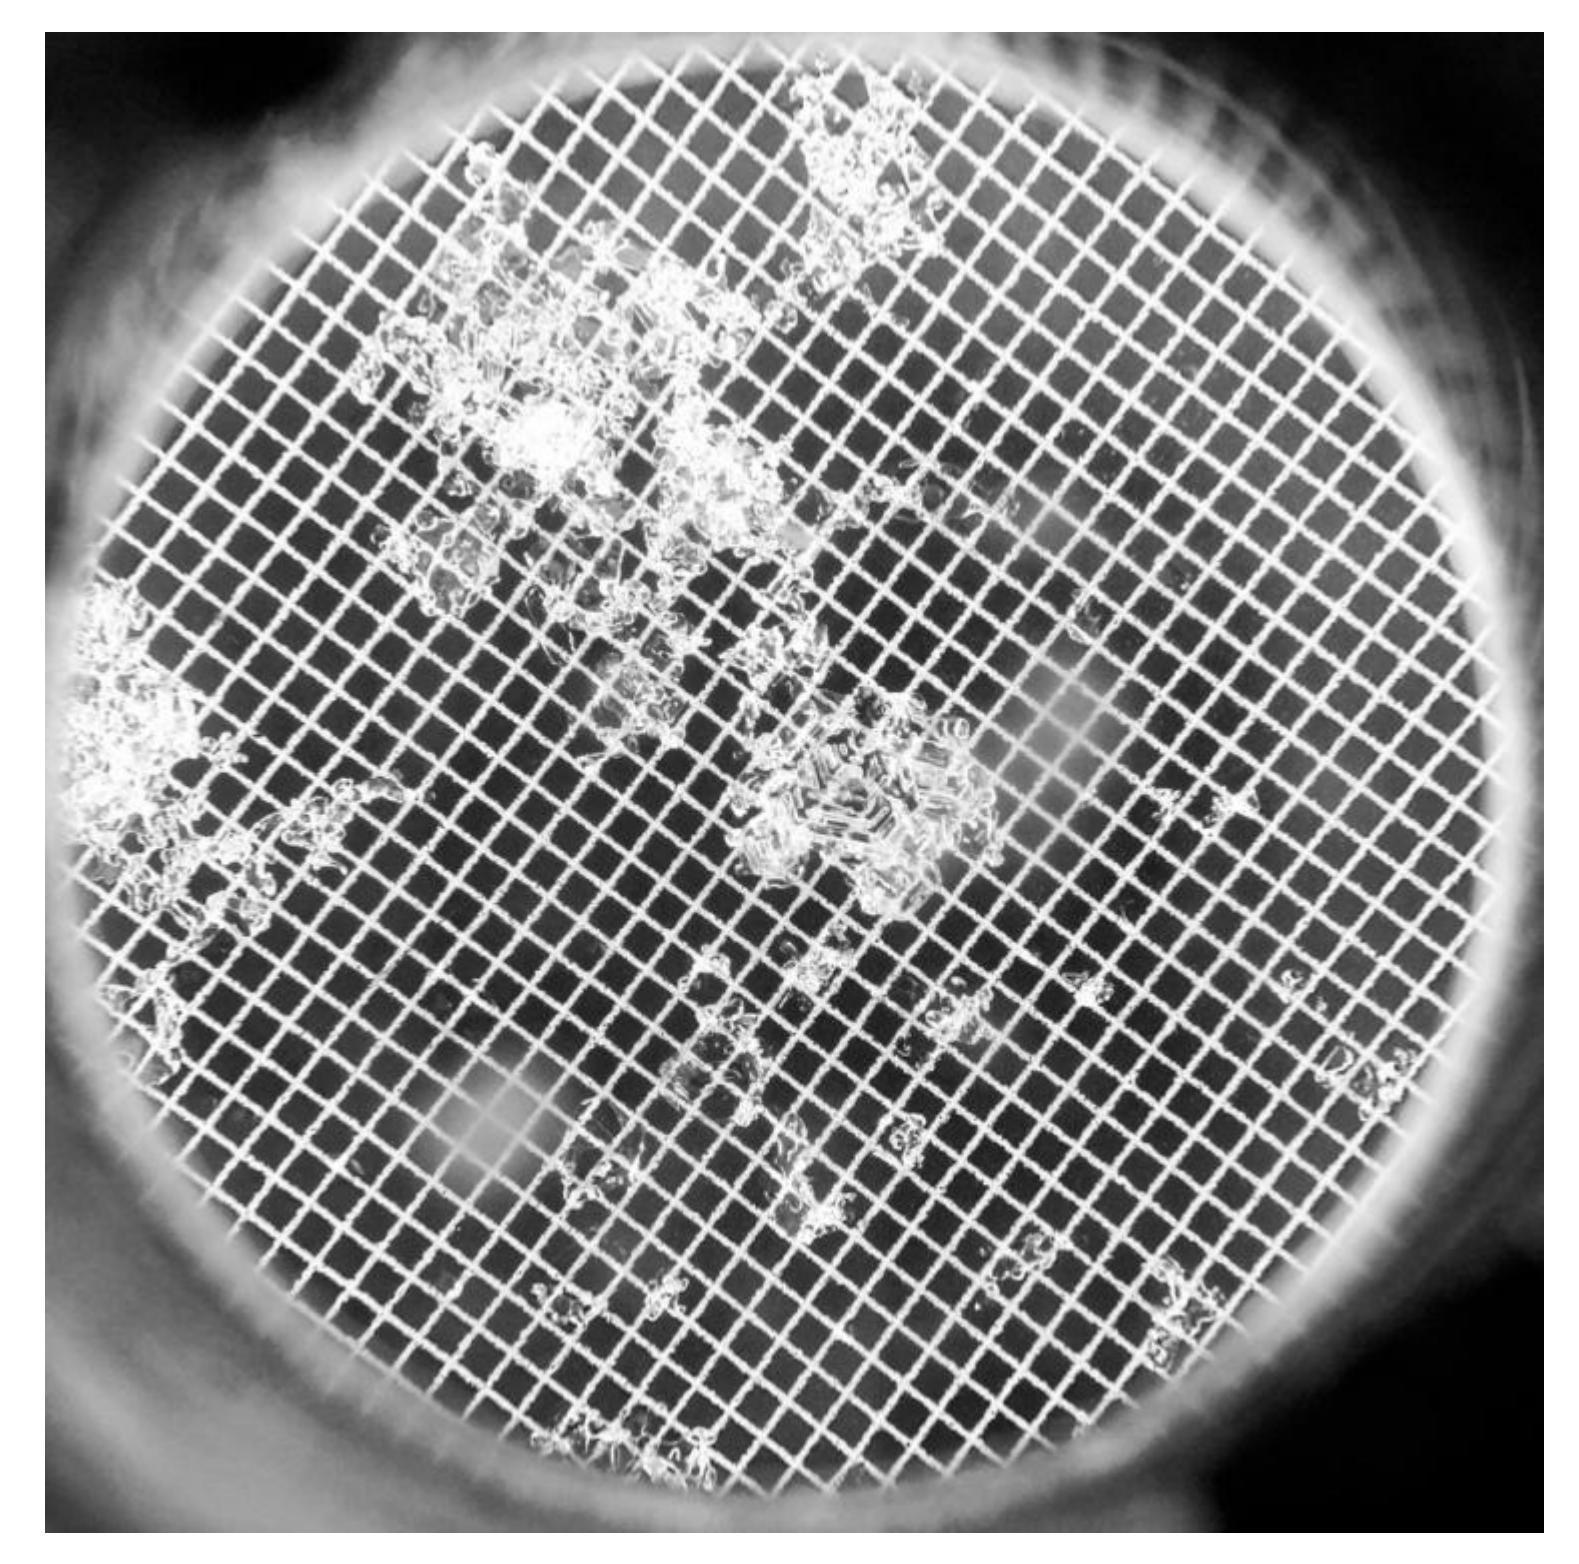
Close up of a crystal from the surface hoar layer buried 2-3 feet deep north of Bridger Bowl and throughout most of the advisory area.

From 4/3/20: "I dug a quick pit at ~7450' on a protected east 36 degree slope - HS 240cm...ECTP18@175 on 3-6mm preserved surface hoar (photos -1mm grid)... All results repeated identically in a second ECT... Seeing the reactive SH layer I opted out of skiing anything that had a distinct rollover or was steeper..." Photo: Z. Miller
